A MODEL NEWS

THE OFFICIAL NEWSLETTER OF
THE MODEL A RESTORERS CLUB (WESTERN AUSTRALIA BRANCH) INC.

Reworking Distorted Manifolds

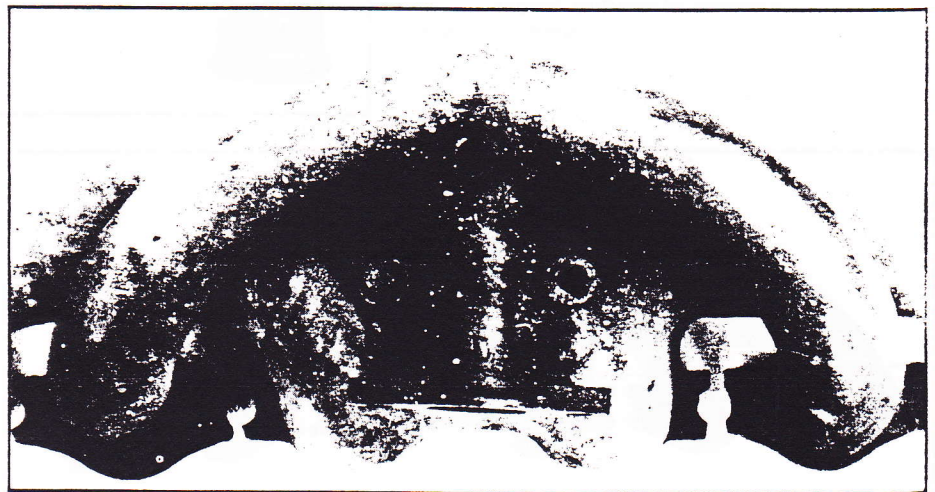
Figure 2 —
Use the intake manifold hole as a drill guide to drill out broken bolt

To drill out the broken bolt start with a 11/32 drill. The intake manifold hole will act as a guide to center the drill on the broken bolt (Figure 2). Drill down only about 1/8 inch to establish the center. Use a 1/4 inch drill to drill through the broken bolt. This drill is slightly smaller than

the "F" tap drill size required for the 5/16 - 18 tap, remove the remaining stock of the old bolt and at the same time rethread the original hole.

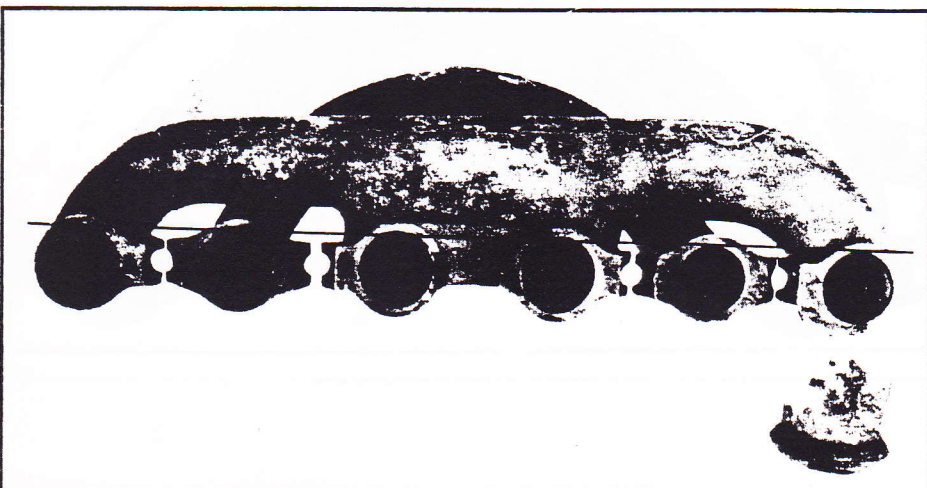
Figure 5 —
Even though ports are still slightly out of alignment, this manifold can be properly installed and will give good performance.
