'A' MODEL NEWS

THE OFFICIAL NEWSLETTER OF
THE MODEL A RESTORERS CLUB (WESTERN AUSTRALIA BRANCH) INC.

CLUTCH CHATTER

WATER PUMP AND FAN

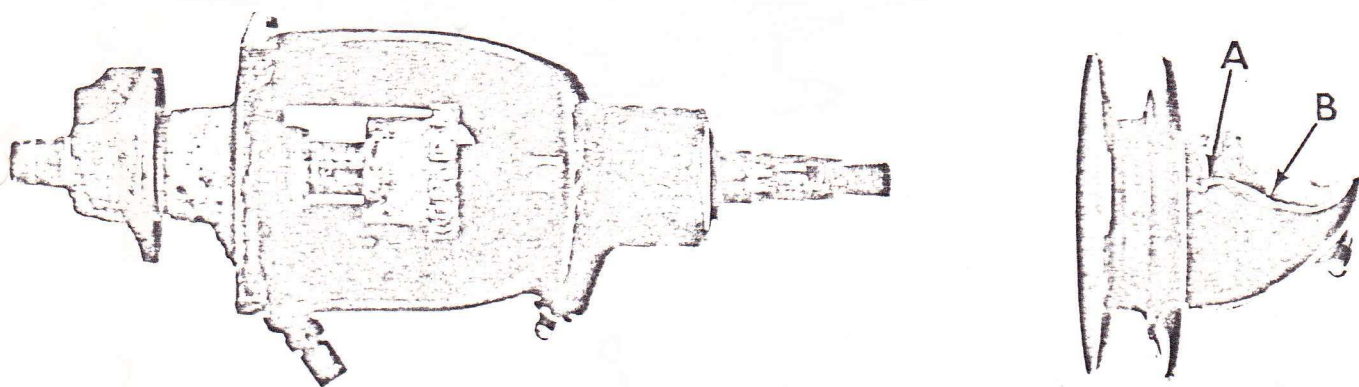
A typical fan assembly which went to pieces. It was evident that a small 1/4-inch fatigue crack started at (A). It progressed another 3/4-inch to (B) before the fan blade broke off. Examination of the shaft showed that the key and shaft had been damaged previously and the fan hub could not seat properly on the shaft. Note the wear on the impeller blades. If you have such a failure on a trip, break off the other half of the blade to reduce vibration, and continue driving at moderate speed until repairs can be made.

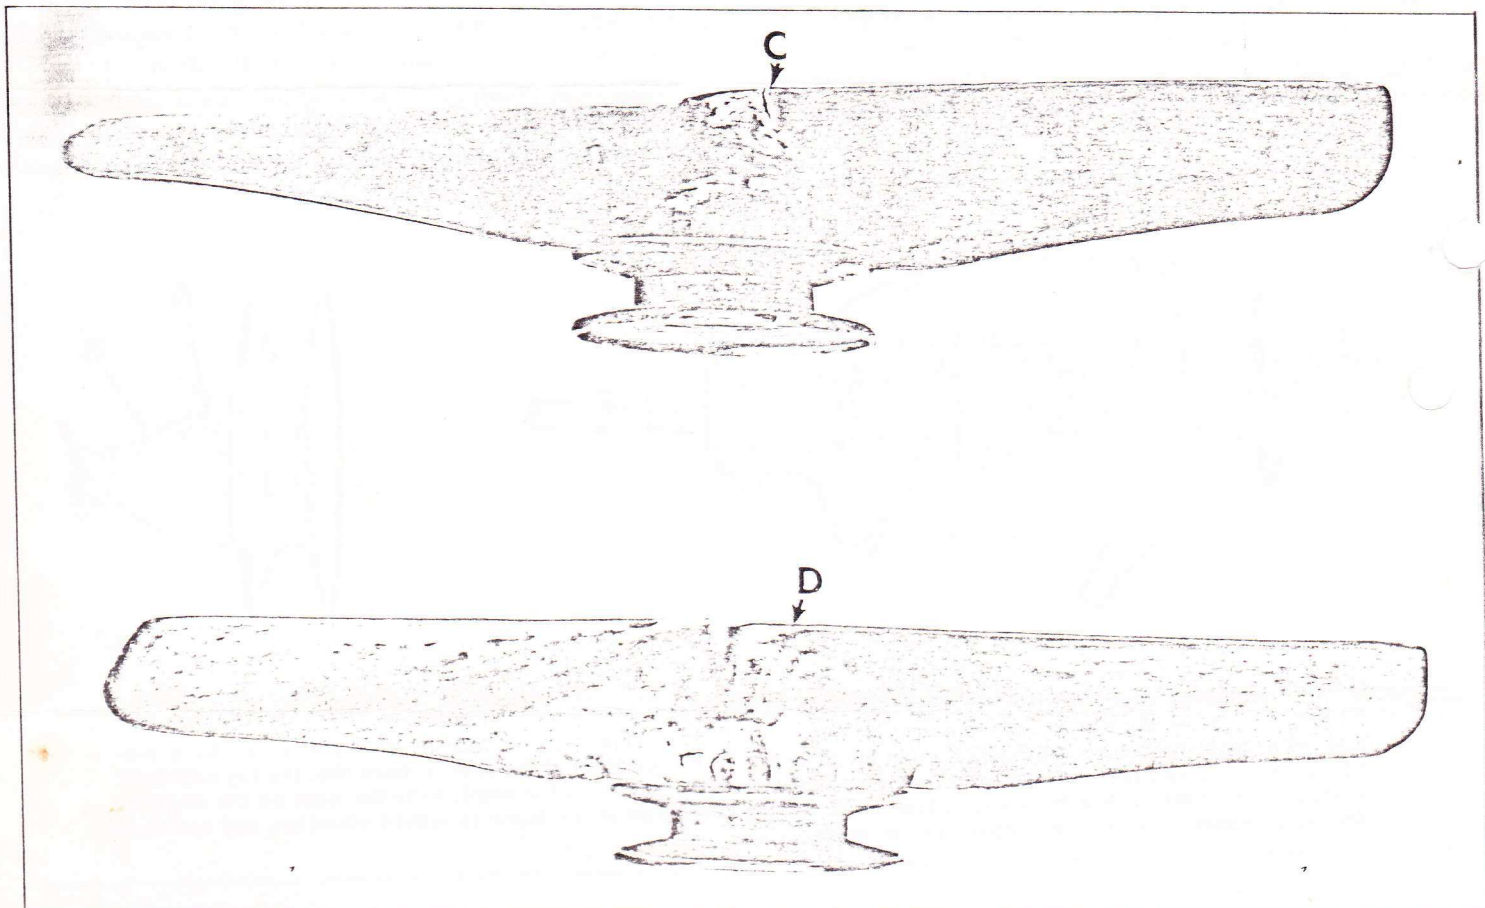
Comparison of two fan blades which appear to be usable. When the upper fan was sanded to bare metal, a crack appeared at (C). All paint was removed from the lower fan and it appeared to be in excellent condition and free of cracks. However, magnaflux revealed a fine crack at (D).

Many two blade fans have fine fatigue cracks near the hub. Some of these cracks cannot be seen by the naked eye. We recommend that the fan blades be taken to a precision engine rebuilding shop to have it magnafluxed. Any cracks which show up should be welded and filed smooth.

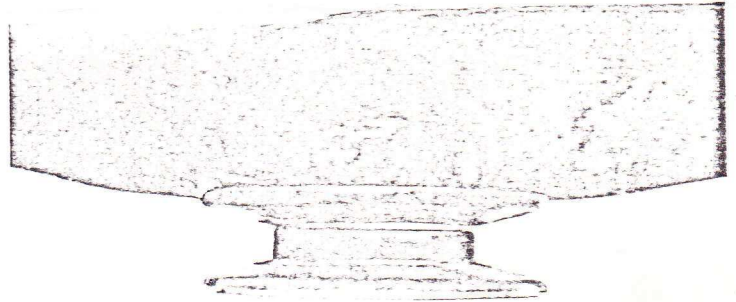
The front half of the pulley on this original fan came loose, probably the result of poor manufacturing. Note that the pulley has cut into the fan blade indicating continued use after failure. With proper welding or brazing the fan can be repaired.
