A MODEL NEWS

THE OFFICIAL NEWSLETTER OF
THE MODEL A RESTORERS CLUB (WESTERN AUSTRALIA BRANCH) INC.

October 13, 1981.

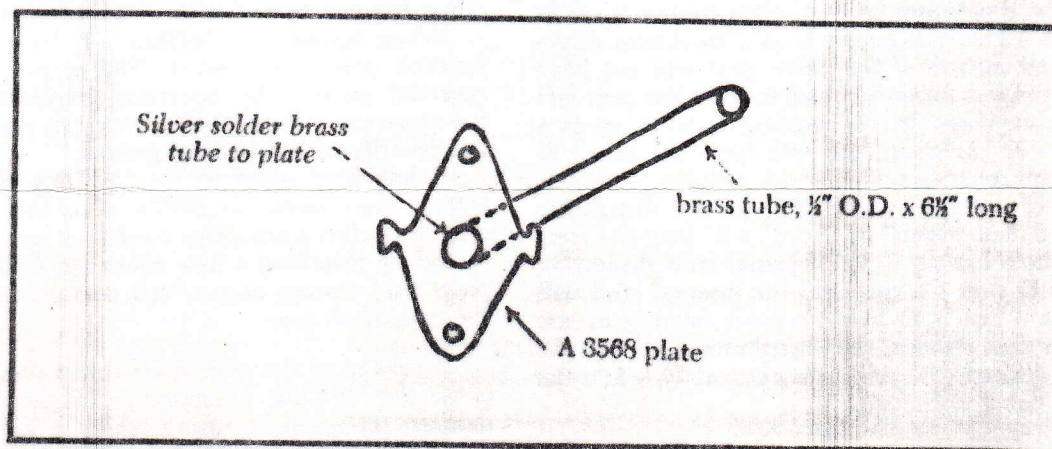
Transmission oil is recommended for use in the MODEL A steering sector housing but this always leaks out. An improved sealing method was used in the 1933 and later Fords and can easily be adapted to the MODEL A steering gear case. Use Part No. 40 3597, steering gear oil retainer tube and plate assembly with gasket No. 40 3592. If you can't find these parts, make the oil seal by silver-soldering a brass tube $6\frac{1}{2}$ " long by $\frac{1}{2}$ " outside diameter onto the MODEL A Part No. A 3568 plate, keeping it square as shown in the accompanying sketch. Then cut a gasket to match the plate. When installed, the gasket seals the oil in the bottom of the housing and the tube extends through the housing to a point well above the oil level. The original MODEL A seal was merely a thick cork gasket ring which was compressed between the light switch, the switch shaft, and the housing; it is not used in the modification described.
