Western Model A News

Official Newsletter of the
MODEL A RESTORERS CLUB OF WESTERN AUSTRALIA, Inc

NOVEMBER, 1993

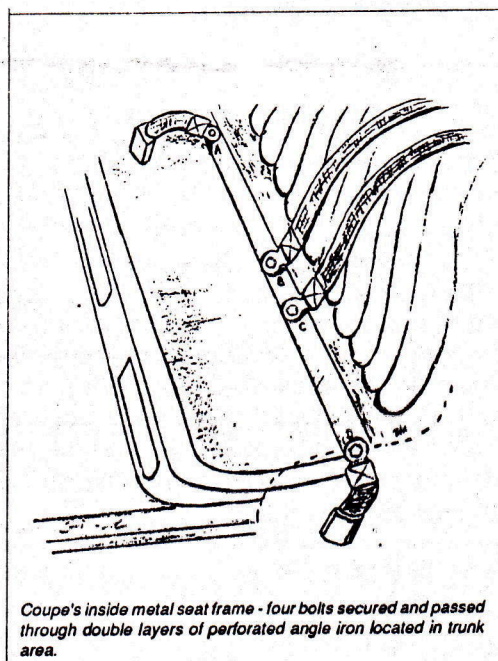
Coupe's inside metal seat frame - four bolts secured and passed through double layers of perforated angle iron located in trunk area.

It is important to secure your seat belts into some steel - whether it be cross frame members, steel seat frames or side rails. Each body style will require the owner's evaluation to find the best location for anchoring sites. If you own a sedan with multilple seating you will be faced with double the task. Strengthen fixing points with steel supports.
